ROOF HAIL DAMAGE ASSESSMENT

Project: Brant Medical Clinic
6801 NW 39th Expressway
Bethany, OK 73008

Date of Loss: 5/16/10
File # 214.443

Date of Site Visit: 9/11/12
Time of Visit: 9:30 a.m.

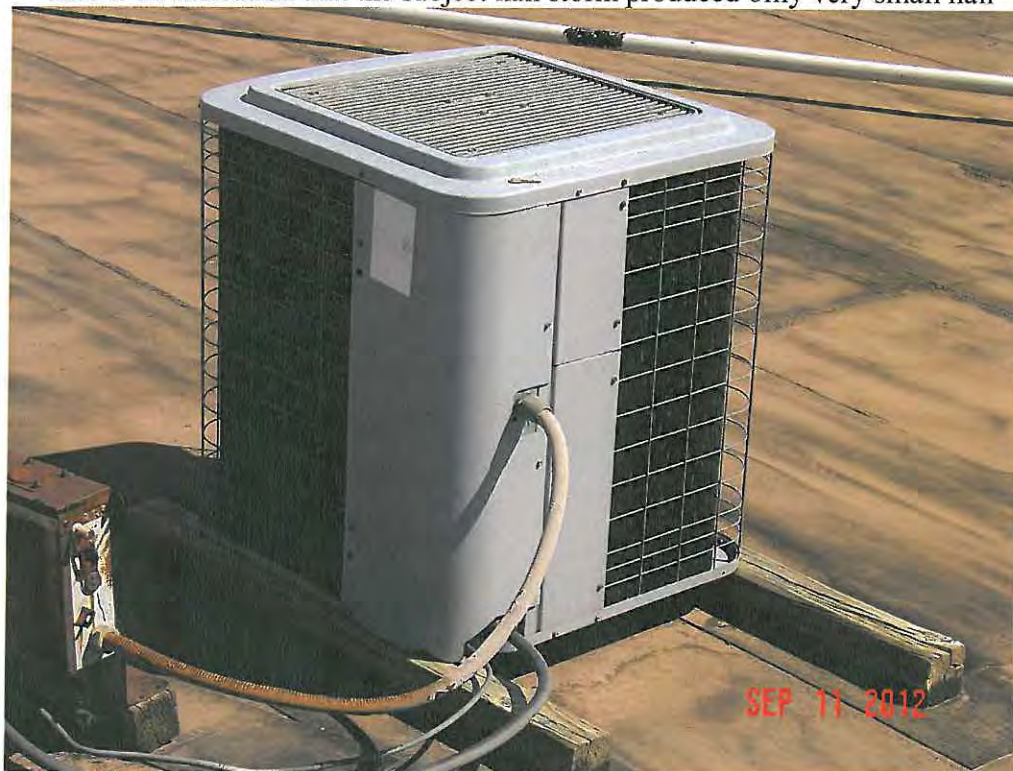
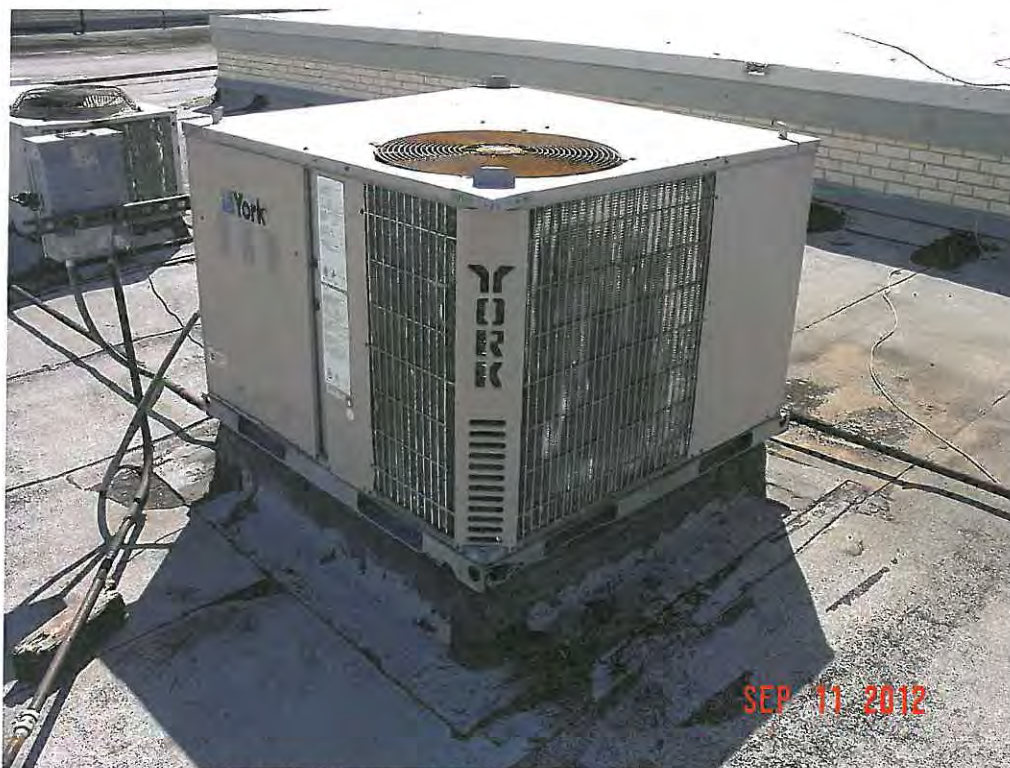
noted some coil fin damage on coils facing all four directions. This damage is inconsistent with any one particular hail storm as hail is typically wind driven from a particular direction during any specific storm. Normally coil fin damage caused by a hail storm is limited to the coil fins facing no more than two directions. The newer air conditioning units exhibit only very minor hail marks on the coil fins, indicating heavier hail damage occurred during hail storms that occurred prior to the subject hail storm.

Coil fin damage on these units is not hail related

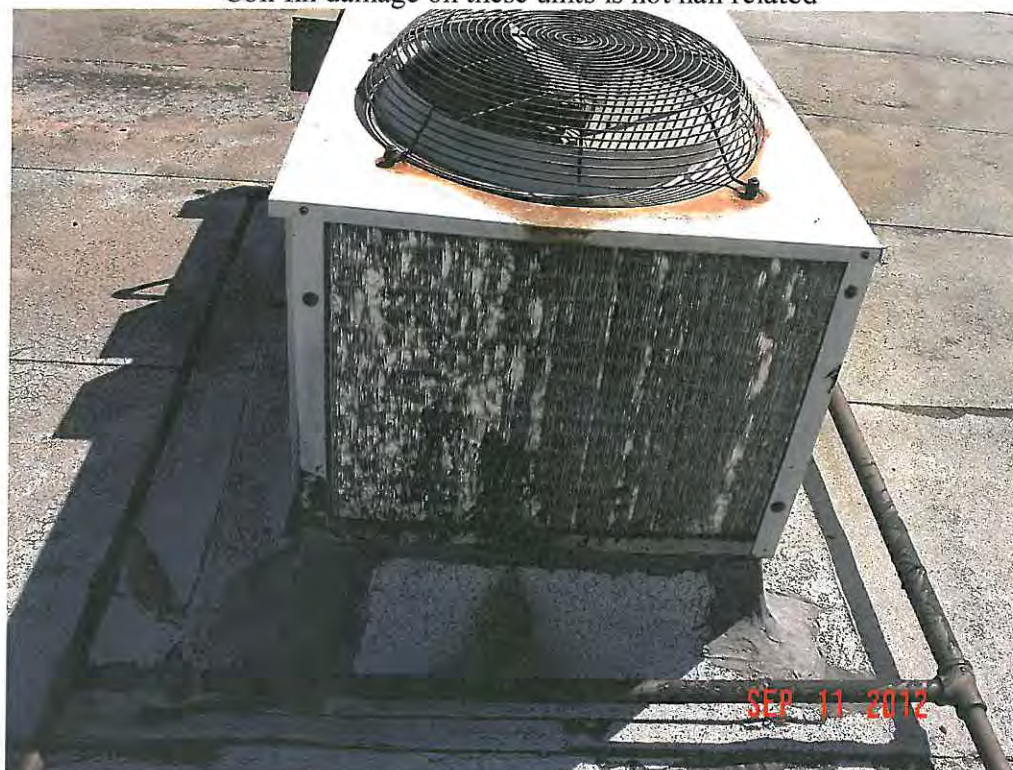
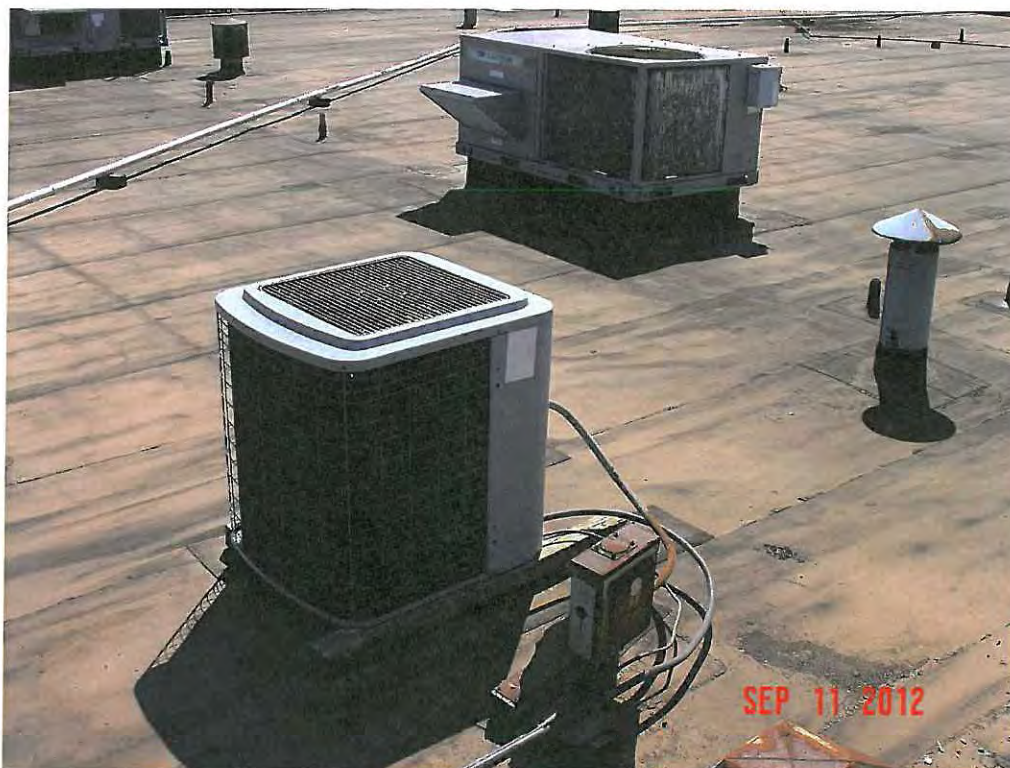
Note the contrast in coil fin damage in the newer unit in the foreground and the older unit in the background

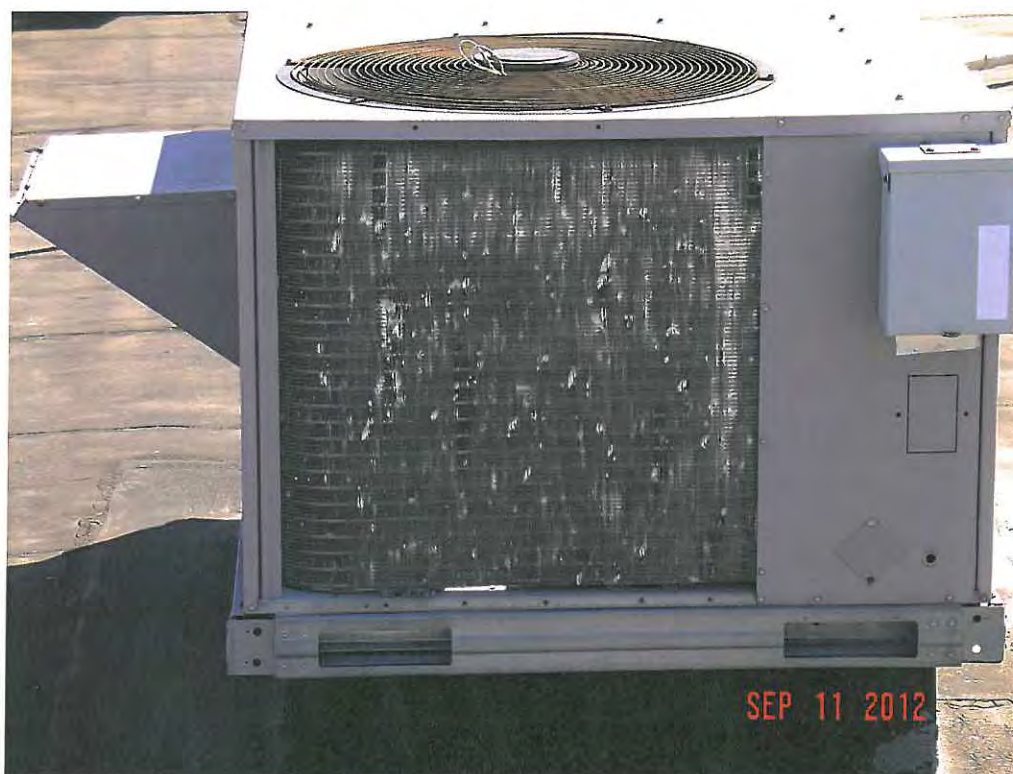
Coil fin damage from prior hail storm
